**Montana Fish,
Wildlife & Parks**

Ravalli County Stream Setbacks

The following photographs illustrate a variety of situations along streams in Ravalli County. The gray rectangles in some of the photos are intended to disguise individual homes. Homes in these pictures vary from new to those established many years ago. Pages 1-10 illustrate recent situations often involving streamchannel changes. The situations on pages 11-17 are not from situations as recent as the previous pictures, but they illustrate issues associated with development near streams. Homes that were built many years ago, that have recently had problems, illustrate that streams do change over time and building more homes near streams will only add to these problems.

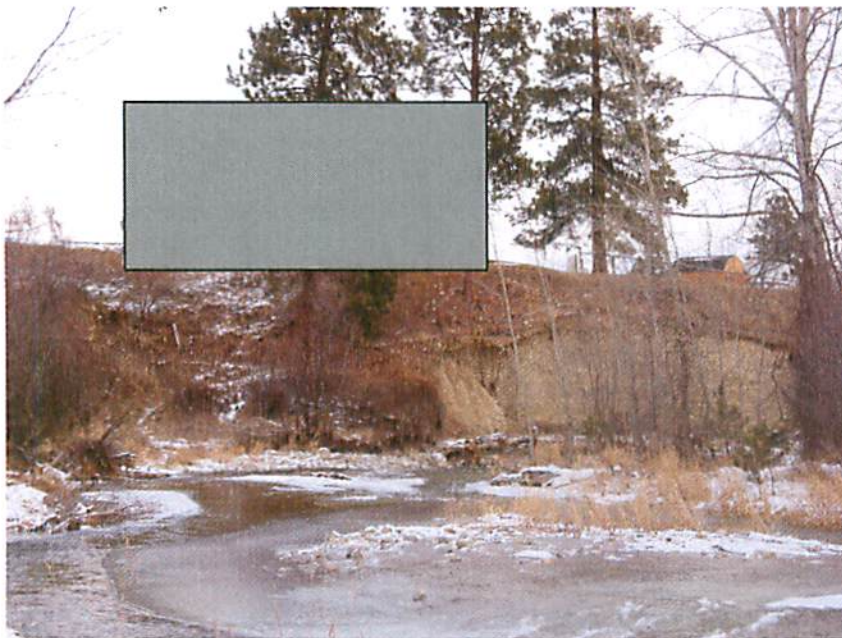
Blodgett Creek (Spring 06) – Note eroding bank – homeowner feared undercutting bank would jeopardize patio and house. He was issued a 310 permit to stabilize bank.

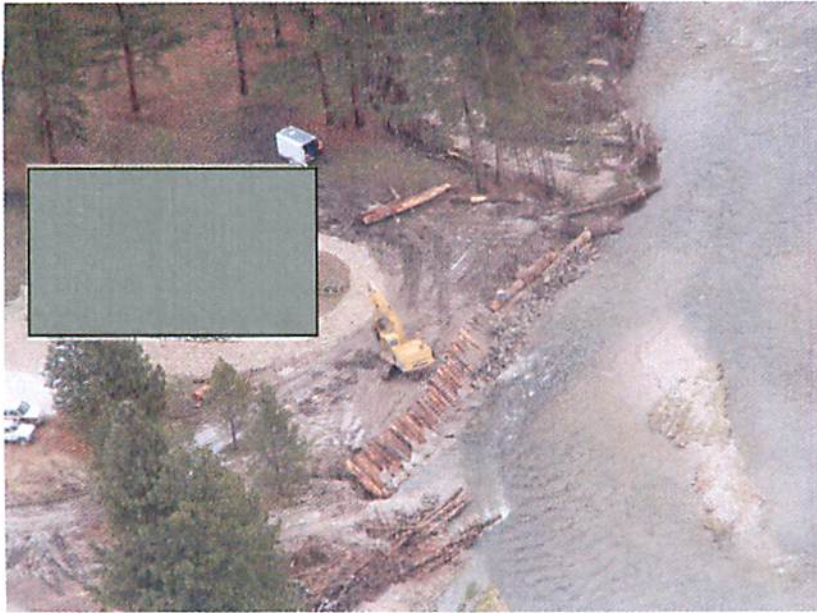
Bitterroot River – downstream of Lost Horse Creek (Spring 07?) – Home moved to site and streambank eroding. Note new streambank stabilization.

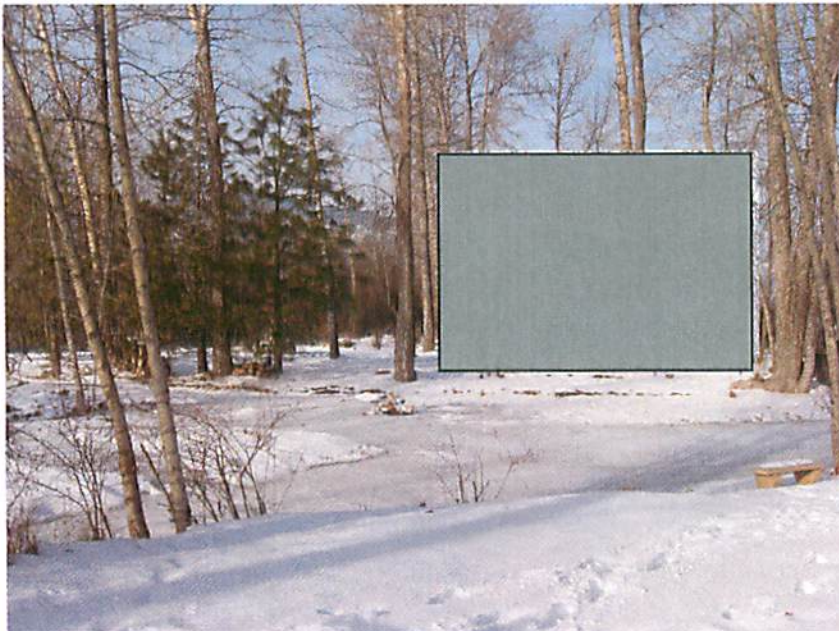
Sweeney Creek (2007) – Creek in foreground – 2 landowners received 310 permit to alleviate flooding and streamchannel migration concerns by hauling out bedload deposition in the creek.

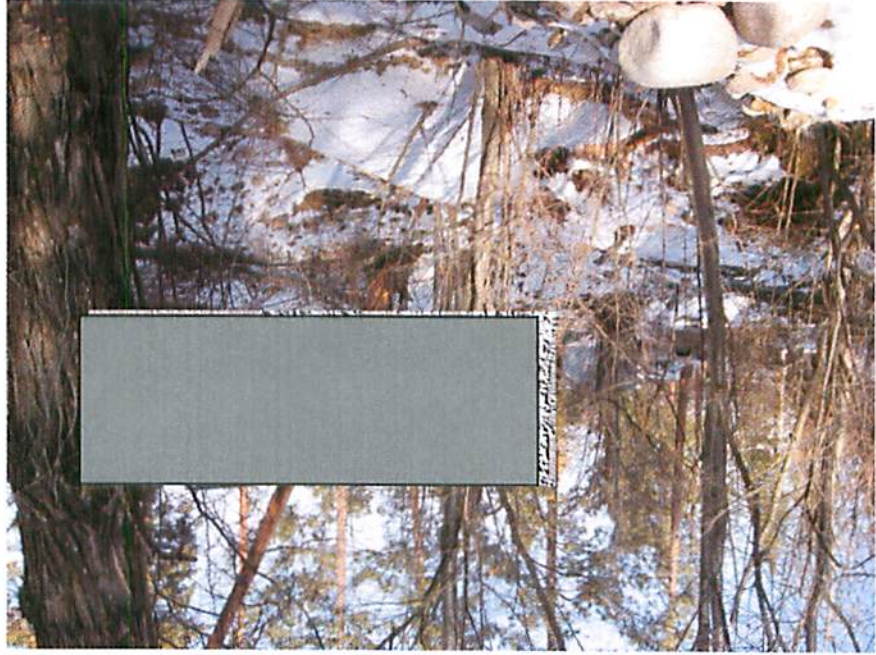
Skalkaho Creek (2007) near BRID siphon – foundation at edge of trees – I assume construction is taking place at this site

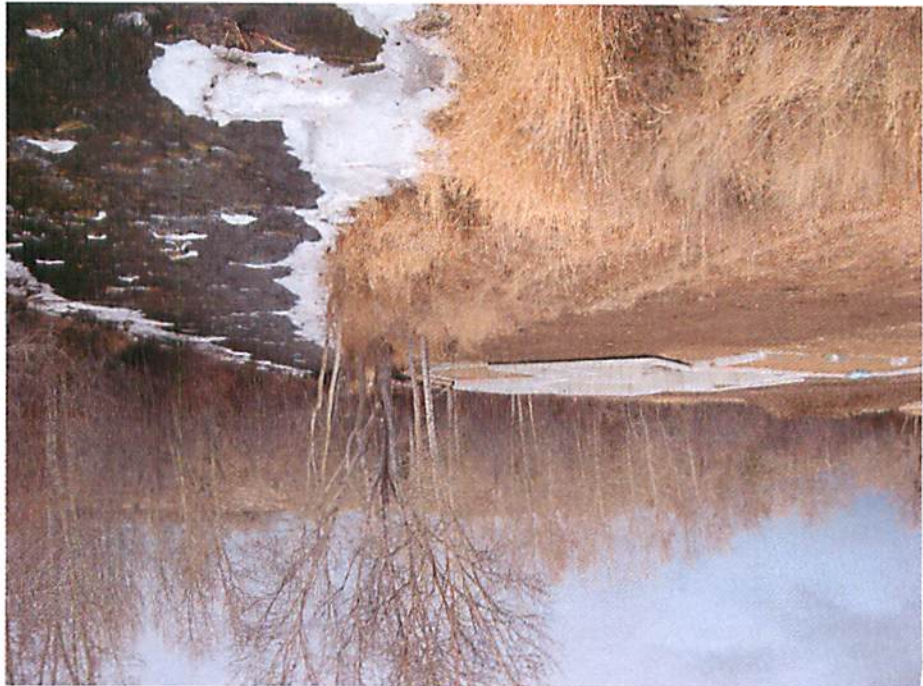
Tincup Creek (2007) - lateral movement jeopardizing pond on right. Owner bulldozed creek to keep it away from pond. Additional bulldozing downstream where lateral creek migration near structure concerns homeowner.

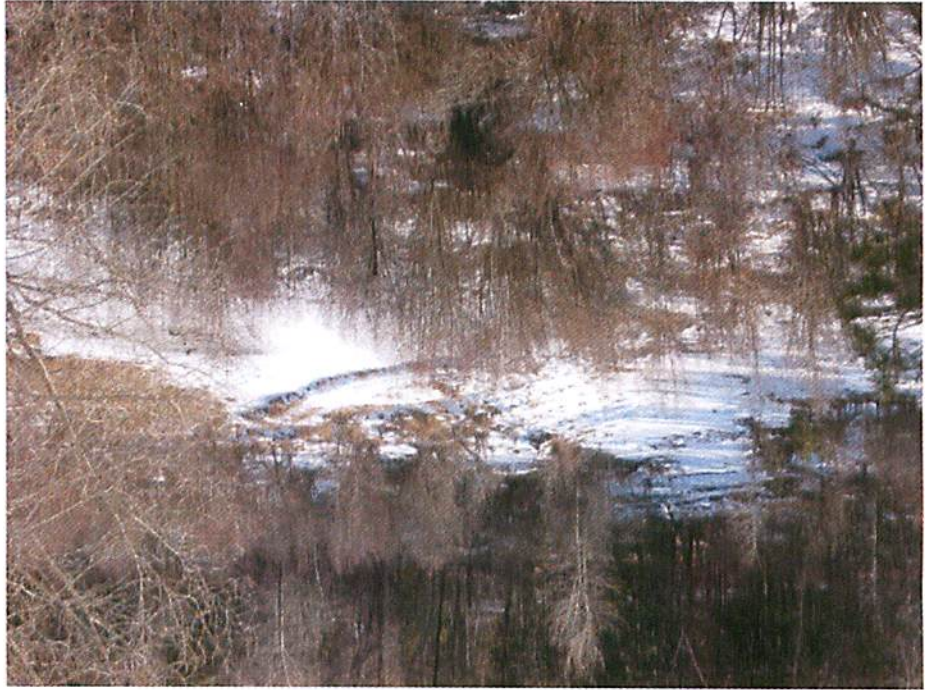
Chaffin Creek – same site as above – home and lawn close to creek.

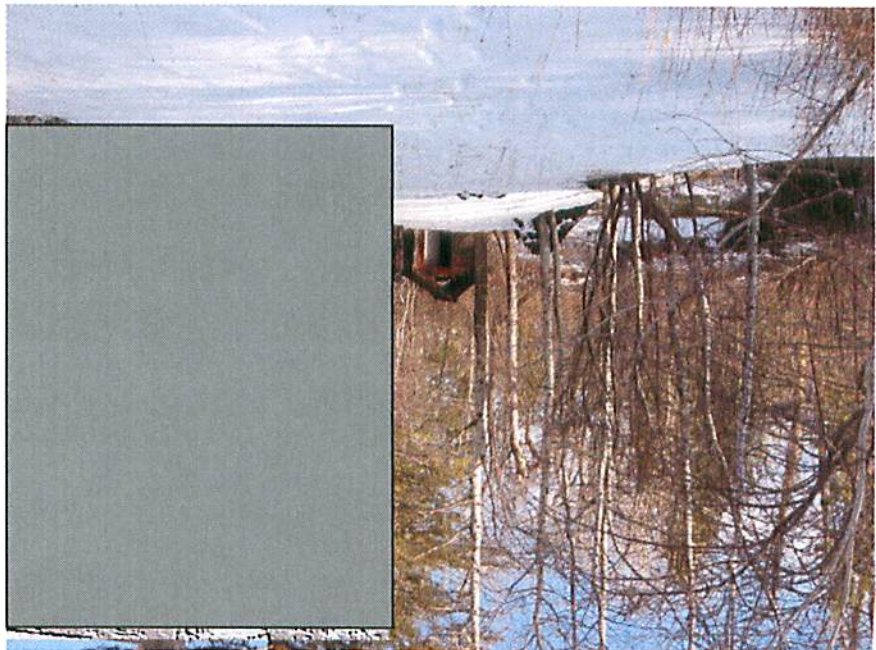
Little Sleeping Child Creek (2007) – pad formed near creek (Creek in culvert).

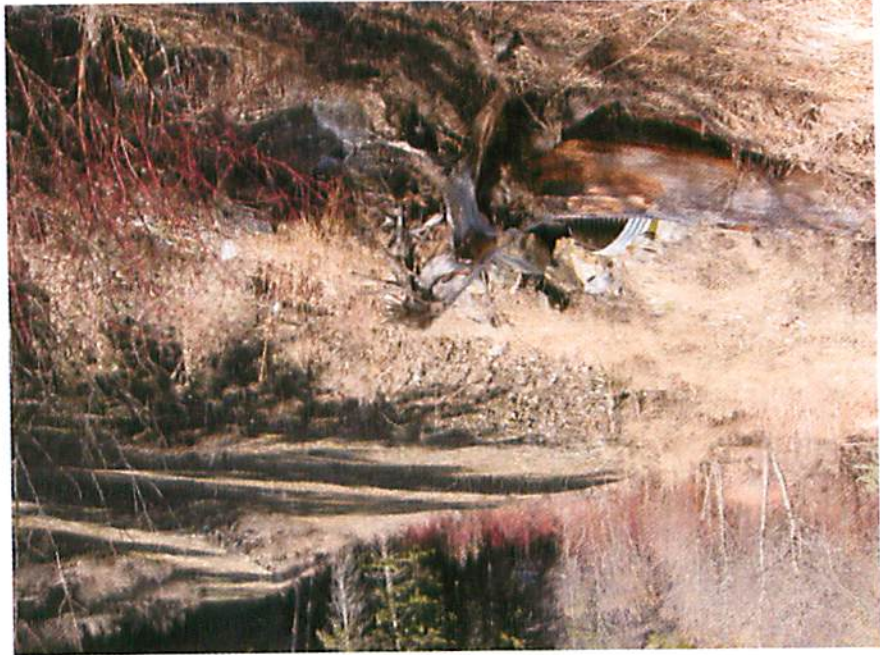
Fred Burr Creek (2007) – lateral stream migration nearly undercuts home (shed fell in). Homeowner issued permit for significant project to move creek away from home.

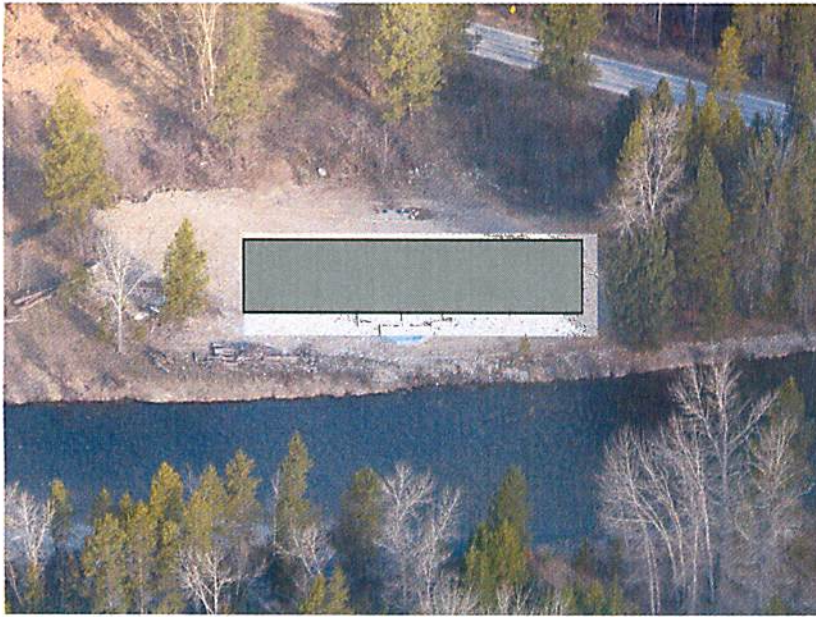
West Fork Bitterroot River (2007) – Foundation between Nez Perce Road and Nez Perce Fork

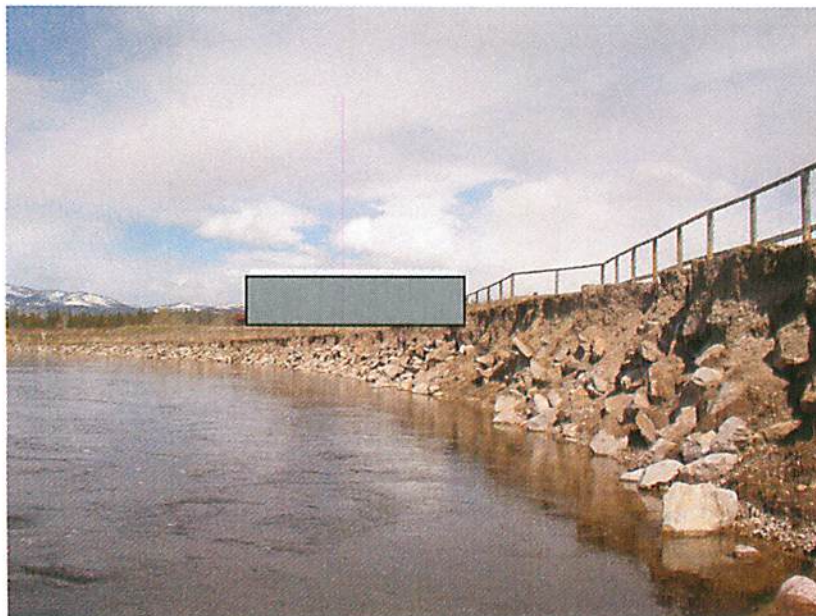
Bitterroot River (2007?, photo given to me)– south of Florence – recent subdivision where developer filled trench back away from streambank with rip rap and river migrated into trench area.

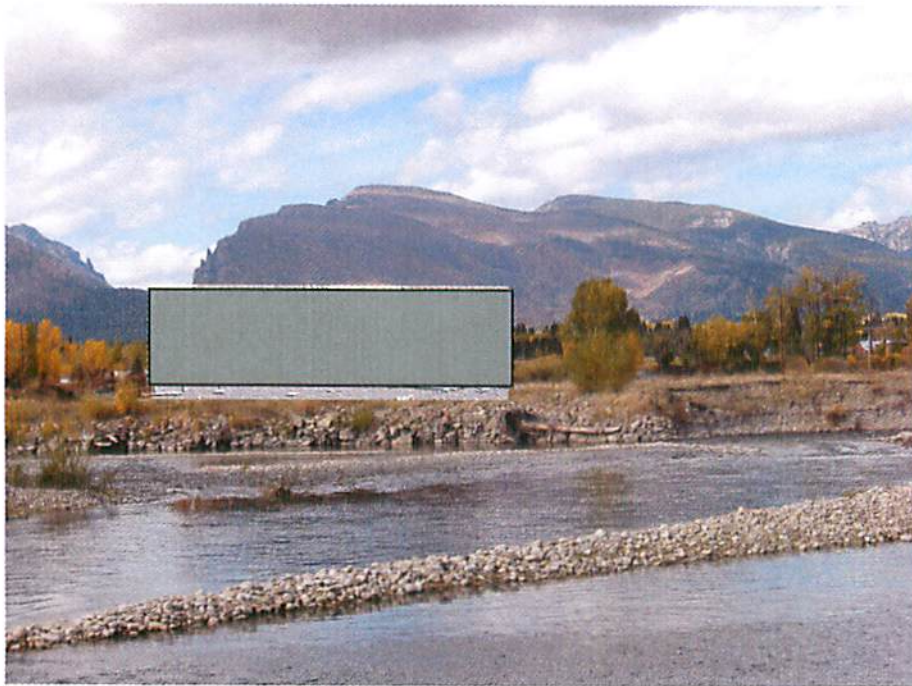
Bitterroot River (2007)– upstream from Woodside – Home under const in 2005-2006 – old rip rap project on streambank (note eroding bank on downstream end, which jeopardizes the stability of the rip rap)

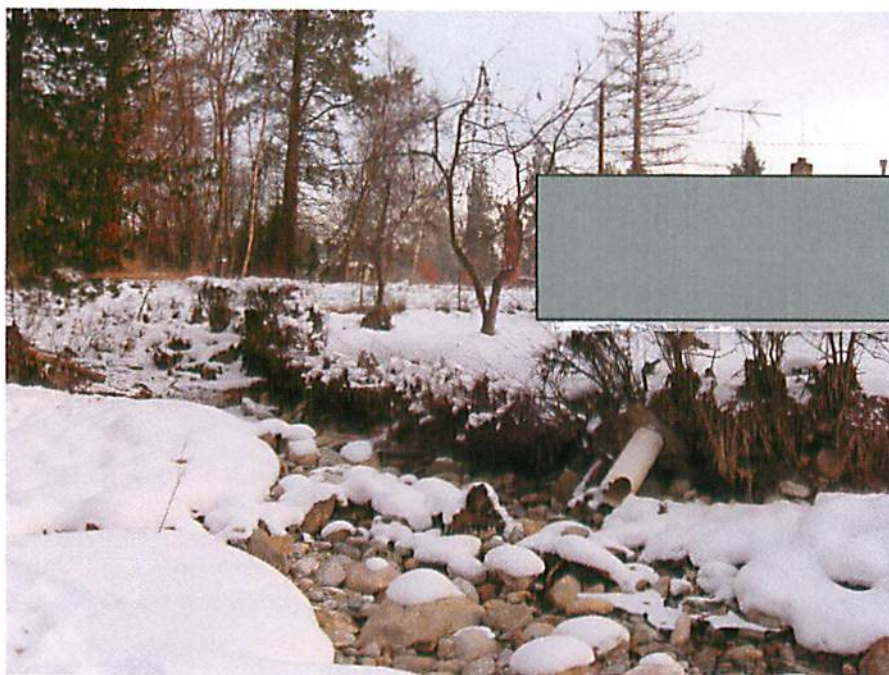
Kootenai Creek (2007)– home on right in jeopardy of streamchannel migration. Homeowner went upstream with excavator and channelized creek on neighbors property to save home. Later was issued permit to alleviate problems for upstream landowner.

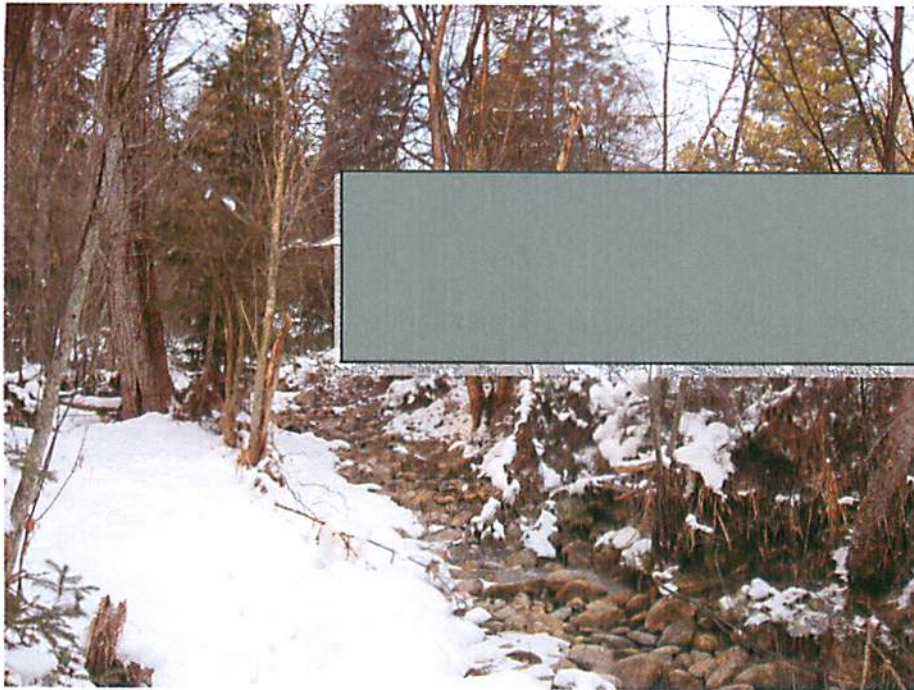
Kootenai Creek (2007 photo)– upstream of previous picture – building near channel that large portion of creek was moving into.

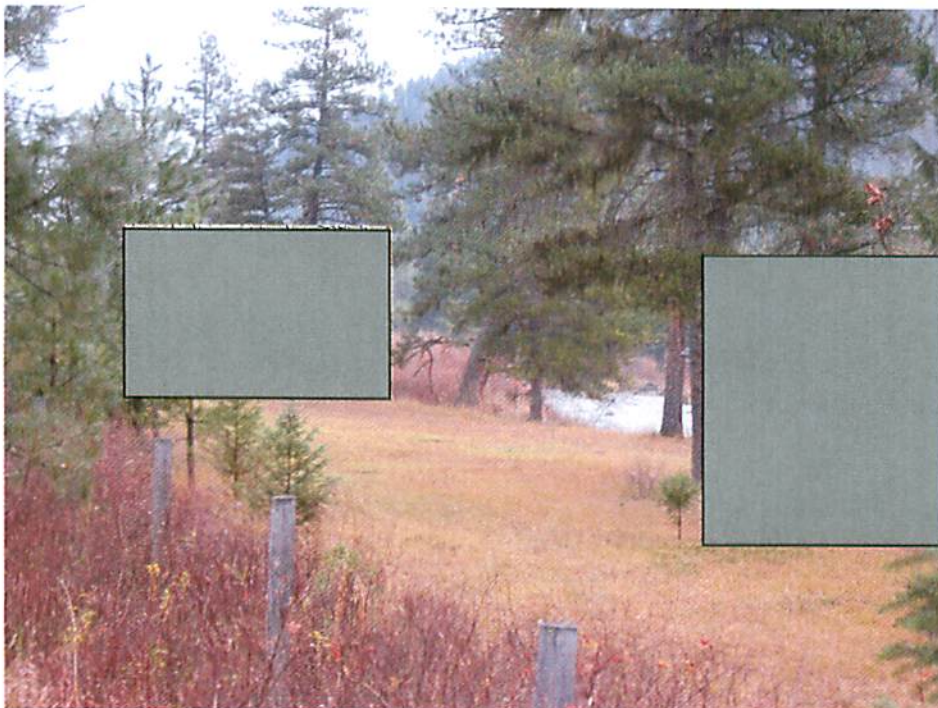
East Fork Bitterroot River (Fall, 2007)– several miles upstream of Sula – house on left under construction. Cabin on right applied to rip rap streambank a few years ago.

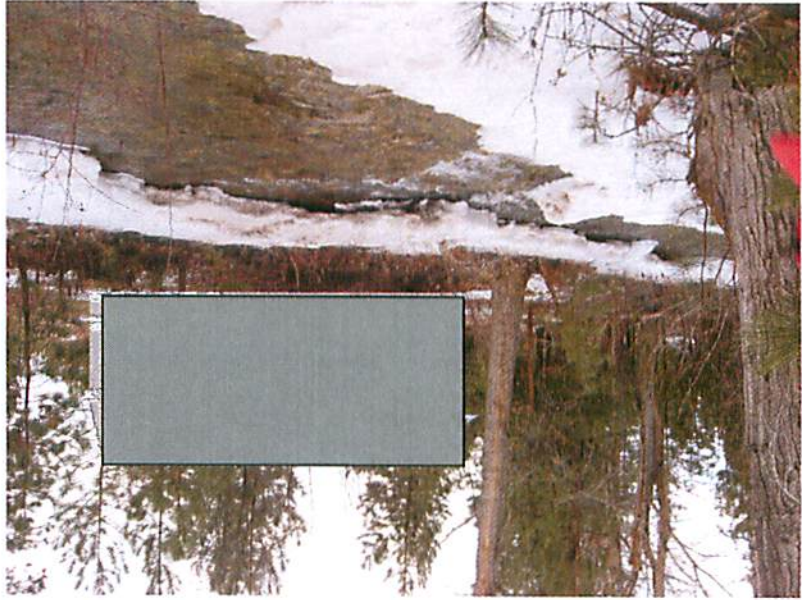
Burnt Fork Bitterroot (Fall 2007) – lawn adjacent to stream – homeowner issued a permit to stabilize streambank. Shallow roots of lawn grass are easily undercut by stream processes.

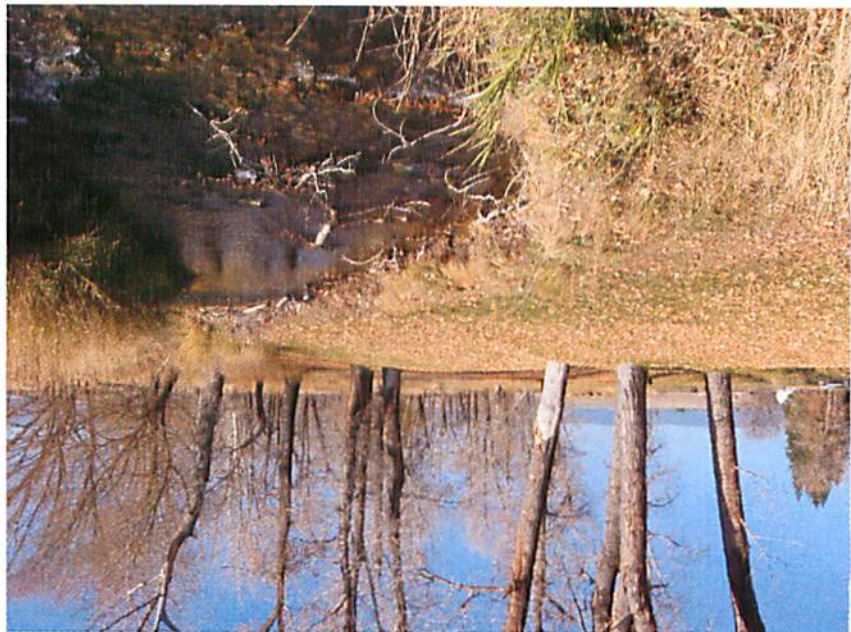
Bear Creek – Note the roof of the new house construction in center left of picture. Picture taken from property of downstream landowner. Have not been onsite of the home, but it is close to the creek.

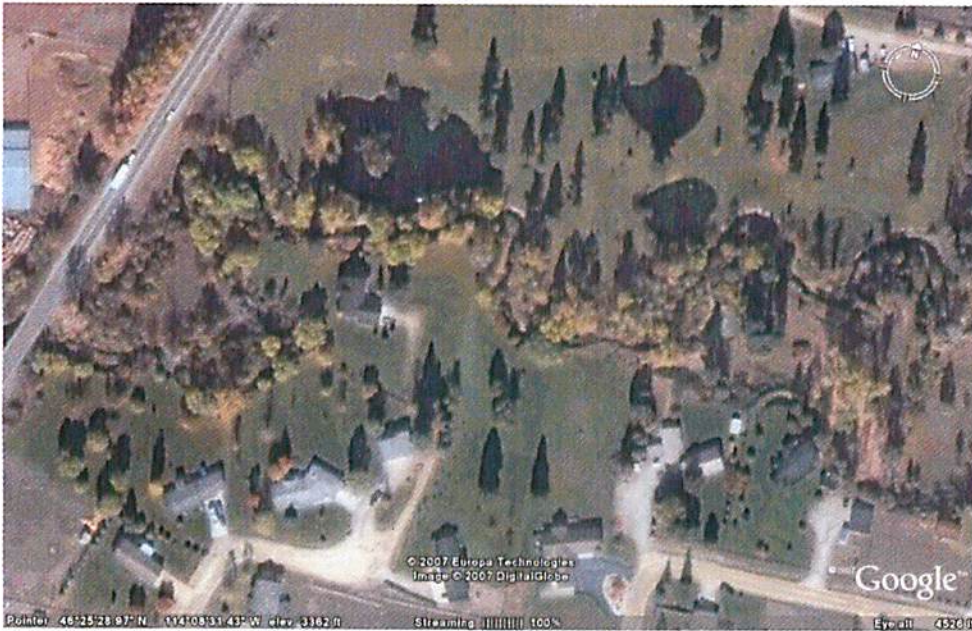
Sweathouse Creek – aerial view of lawn development near and along creek. Note home in center left, next to creek..

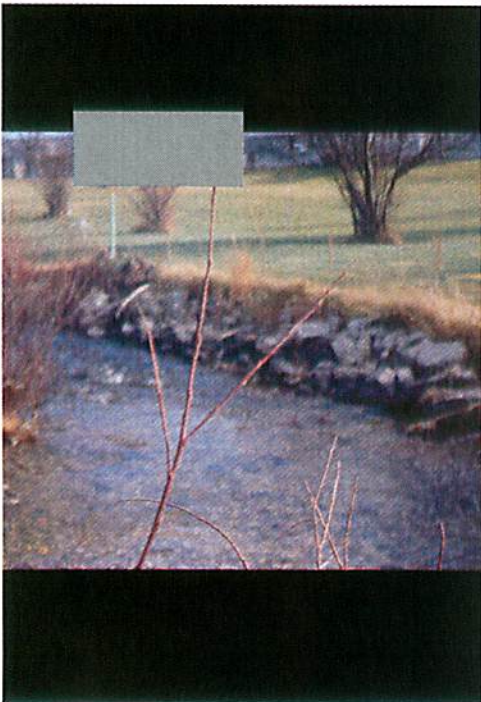
Sweathouse Creek – same area as above. Lawn grasses have shallow root system. Rip rap required to stabilize streambank.

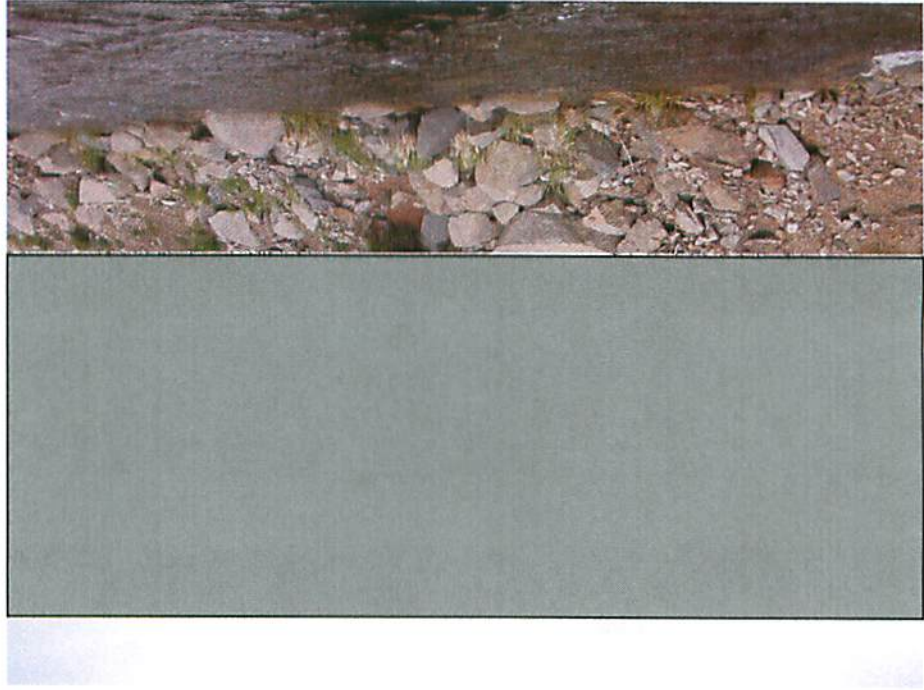
North Bear Creek (2007 photo) – Home near streambank (has been there many years).

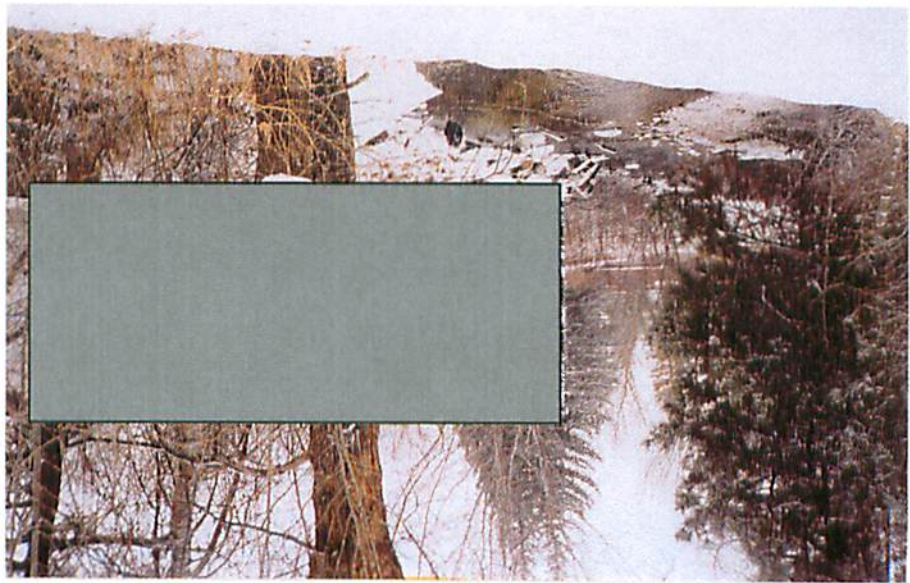
Sweathouse Creek (2007)– Home back from creek, lawn close to creek

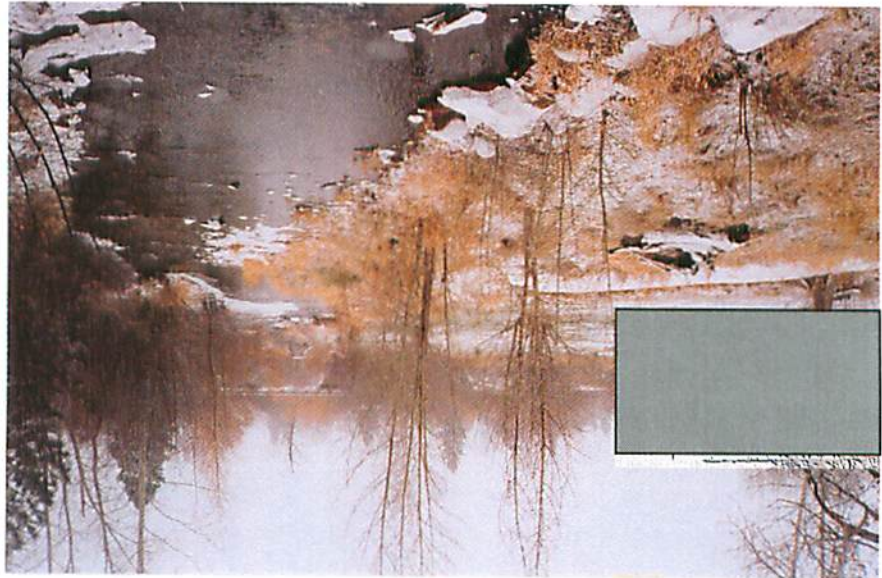
Little Sleeping Creek (2005 photo)– Home away from creek but development close to creek.

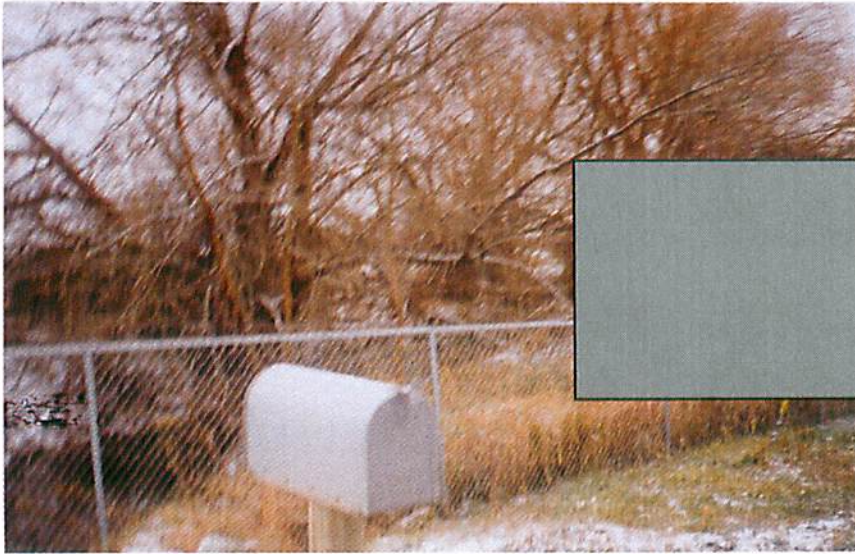
Willow Creek (2007 photo)– Older home near creek.

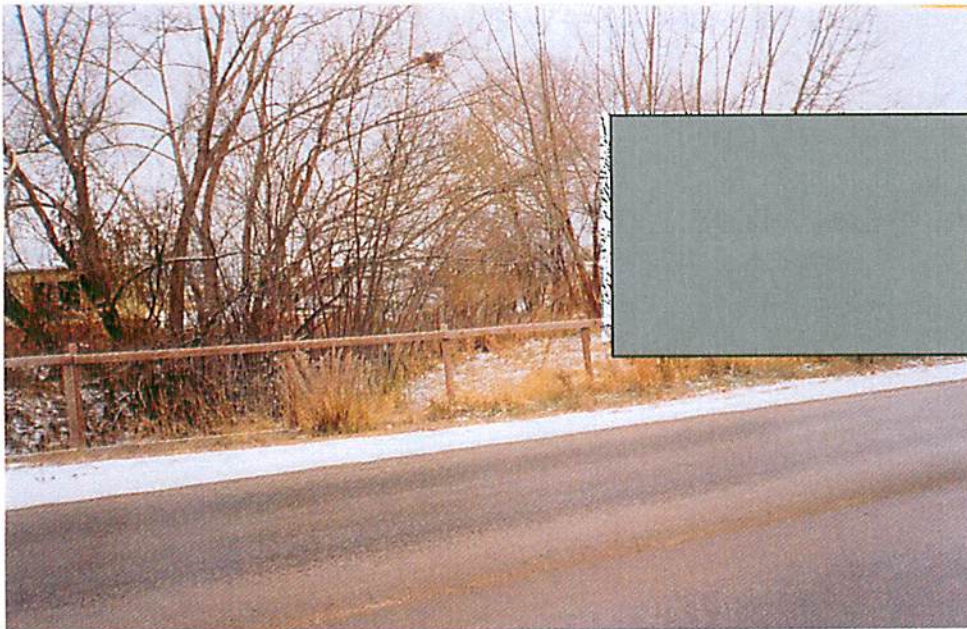
Willow Creek – (2007 photo) across highway from previous site. Creek undercutting patio.

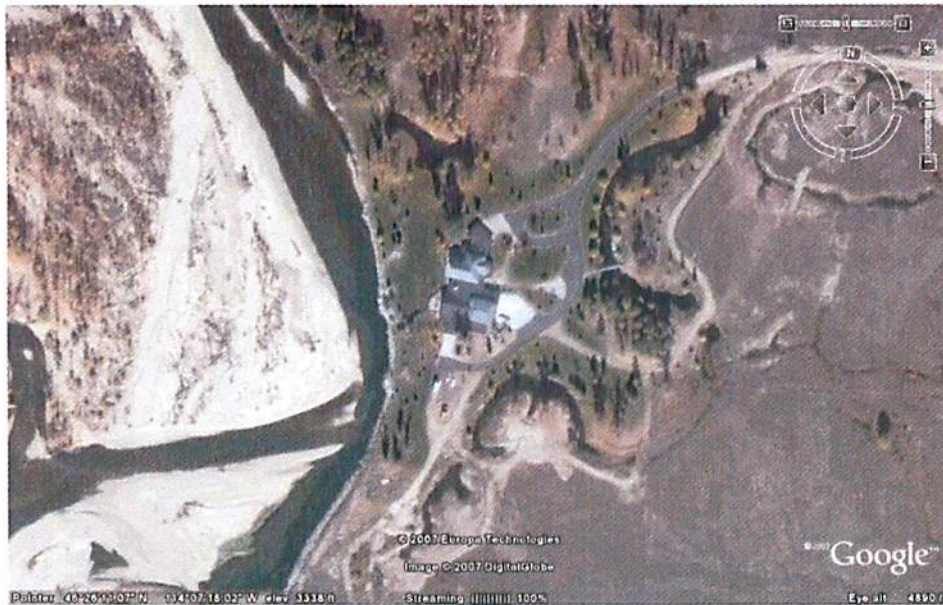
Bitterroot River near Bell Crossing – streambank rip rapped near this home while under construction several years ago. The River migrated to the east a long distance during construction and threatened the home.

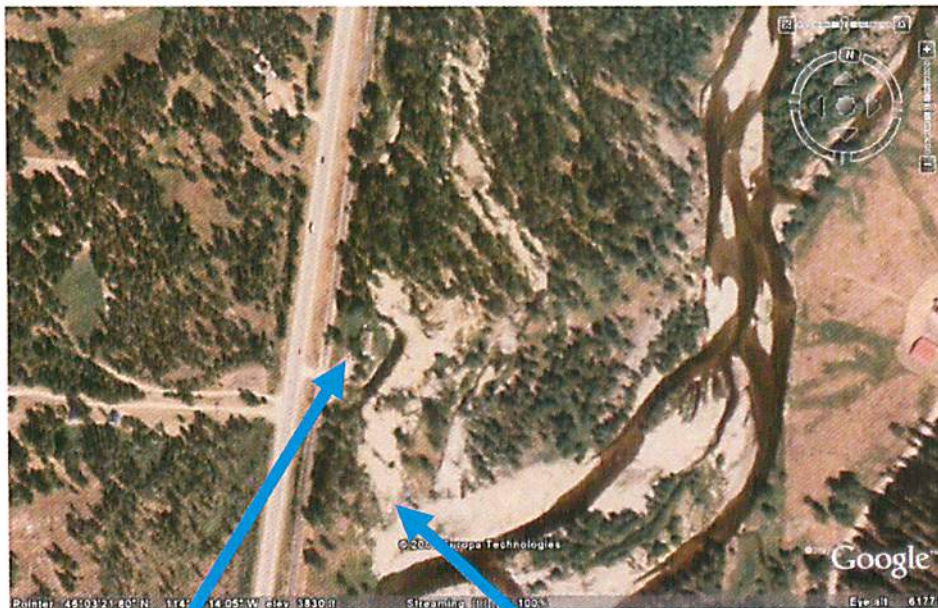
Bitterroot River – The dike was constructed to keep the river from changing channel and flooding homes north of Darby. The labelled homesite has flooded in the past and homeowners to the north are concerned about flooding and streamchannel migration. Floodplain regulations should prevent this type of flooding, but do not prevent problems caused by streamchannel migration as illustrated below.

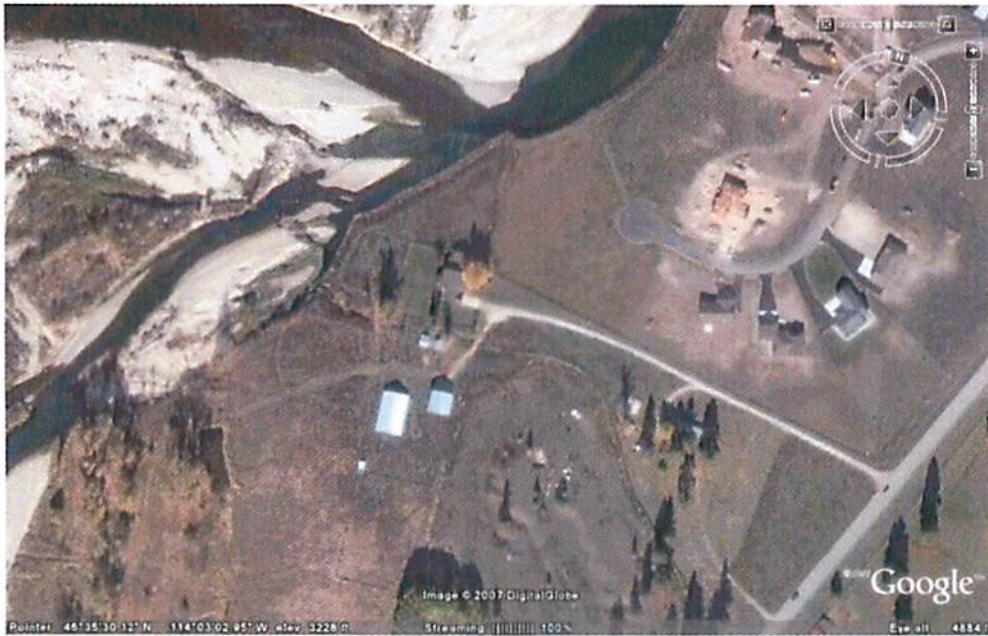
Bitterroot River – south of Florence. Home in center of picture is on a high bank but river was eroding it so the homeowner paid for streambank stabilization about 3 years ago. Straight streambank just north of home is the stabilized reach.

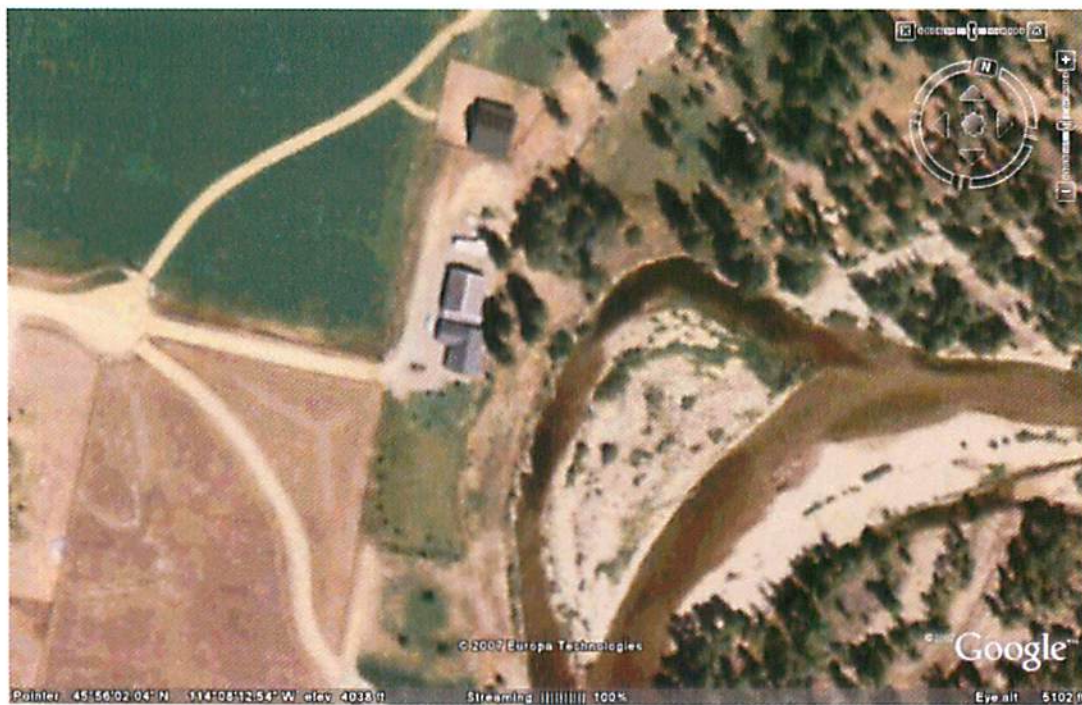
West Fork Bitterroot River near Conner – The home is on a high bank, not in the floodplain, but the river was laterally migrating and eroding the toe. Homeowner paid for streambank stabilization and recontouring of the slope about 10 years ago.

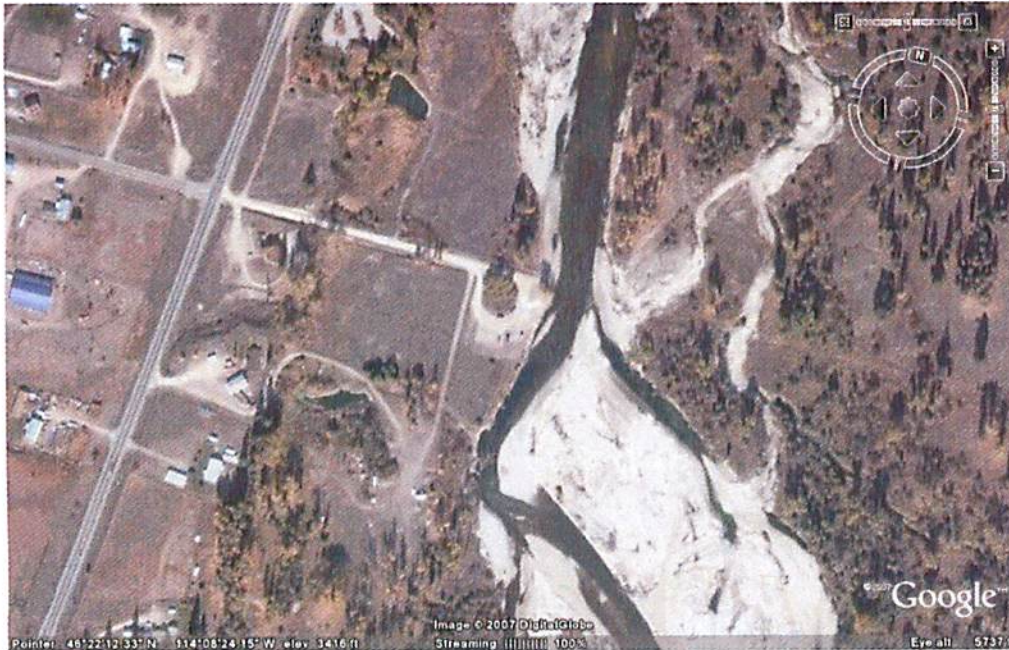
Bitterroot River (West Tucker Fishing Access Site in center of picture) – Not a homesite, but illustrates the difficulty of dealing with laterally migrating Bitterroot River. The streambank of this popular fishing access site has been stabilized twice with rootwads that failed. The third treatment was rip rap that needs maintenance or it may fail..

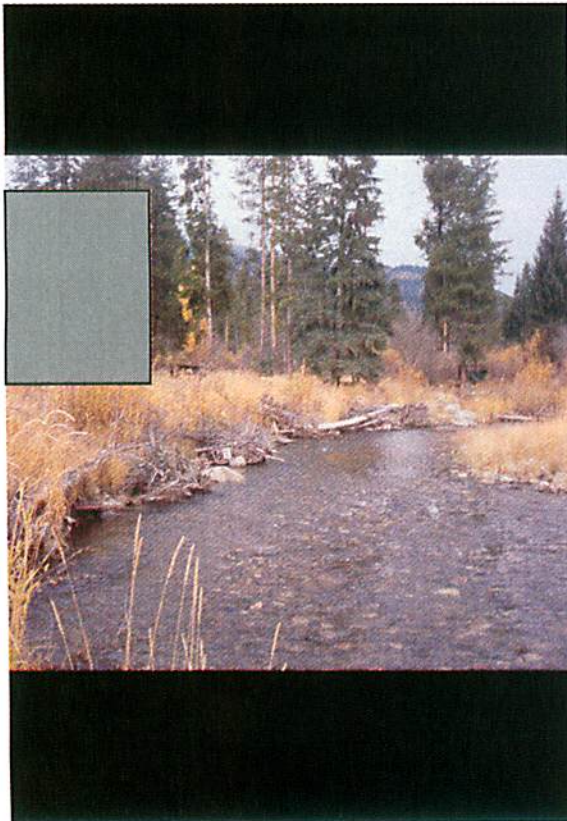
West Fork Bitterroot River – This home was built near the streambank and subsequently a bank stabilization project was permitted to stop lateral stream migration
